## ЕКОЛОГИЧНИ ПРОБЛЕМИ В ДОЛЕН ДУНАВ СВЪРЗАНИ СЪС СЪСТОЯНИЕТО НА НАНОСНИЯ ОТТОК

### SEDIMENT RELATED ENVIRONMENTAL PROBLEMS AT THE LOWER DANUBE

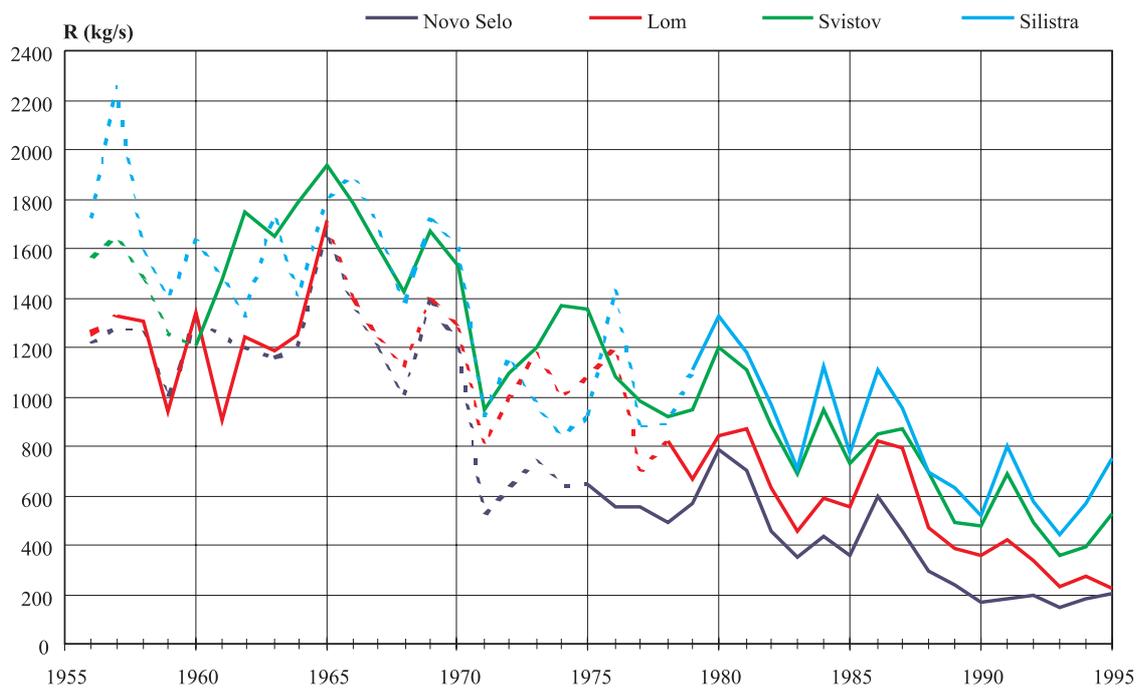
**Fig.2.** Suspended sediment load hydrographs of the Danube river (Bulgarian stations)  
 (Source: *Morphological Changes and Abatement...*, Gutknecht, Modev, Bondar, 2000)

The main suspended load time series on the Danube river from Romania and Bulgaria are shown in Figs. 1 and 2. In Fig. 3, the contribution of the Danube river and the tributaries to the suspended load total input to the downstream section is shown. It is important to note that the tributaries contribution is, roughly assessed, around the half of the total. All inputs, during the considered time, decreased approximately at the same rate. For 1983-1995 this results,

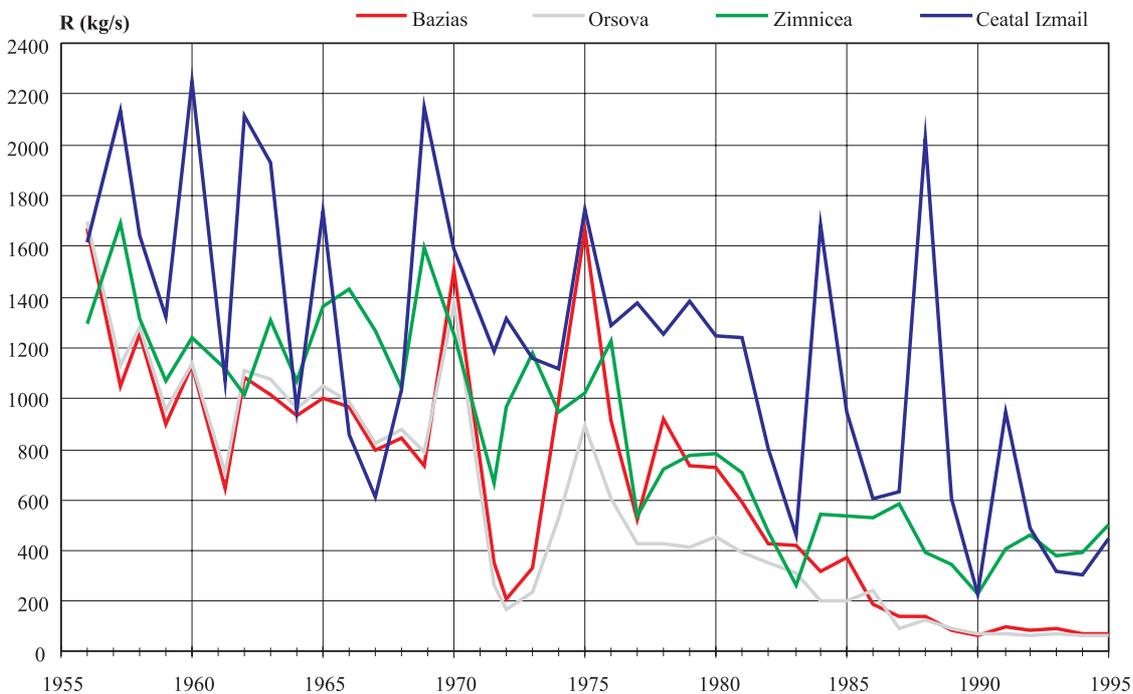
**Fig.1.** Suspended sediment load hydrographs of the Danube river (Romanian stations)  
 (Source: *Morphological Changes and Abatement...*, Gutknecht, Modev, Bondar, 2000)

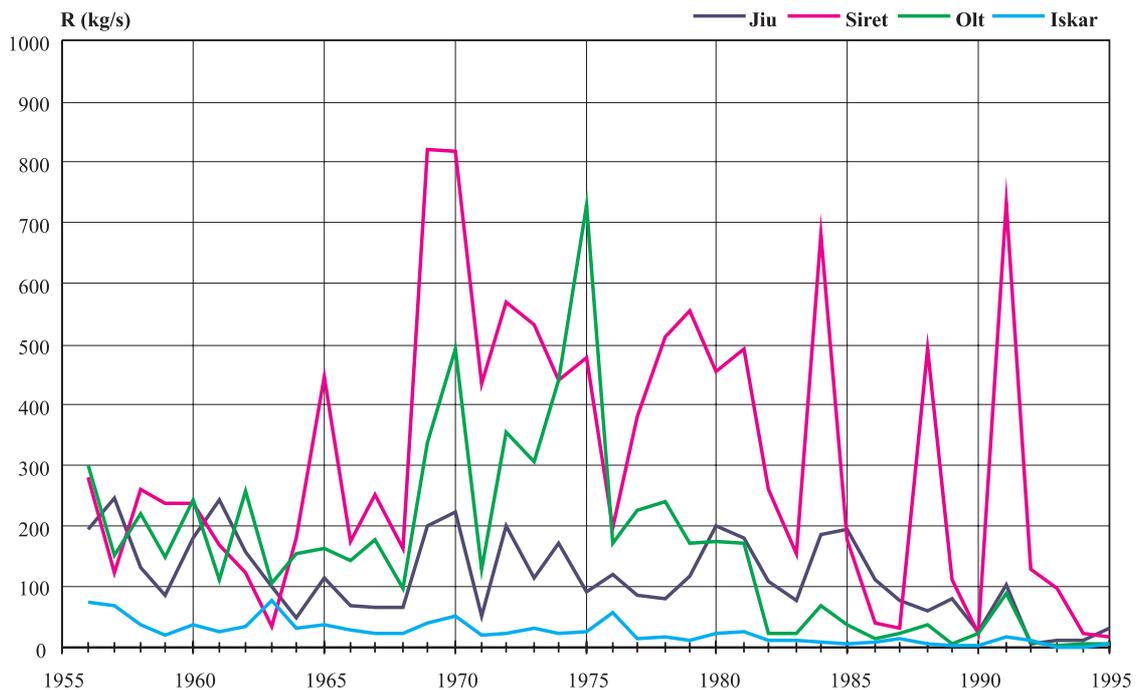
**Fig.3.** Suspended sediment load hydrographs of the main downstream Danube river tributaries

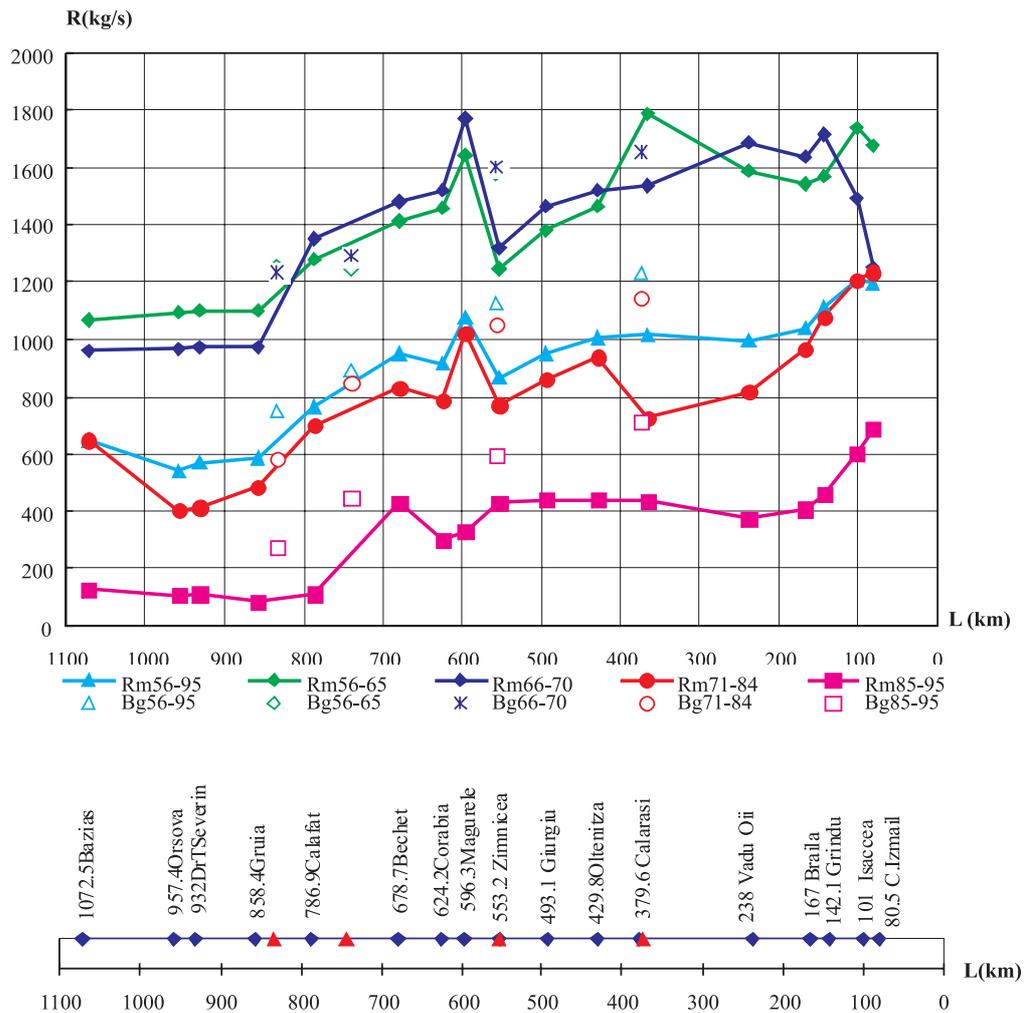
**Fig. 4.** Suspended sediment load along the Danube river for different time periods (Rm-Romanian data;Bg-Bulgarian data)

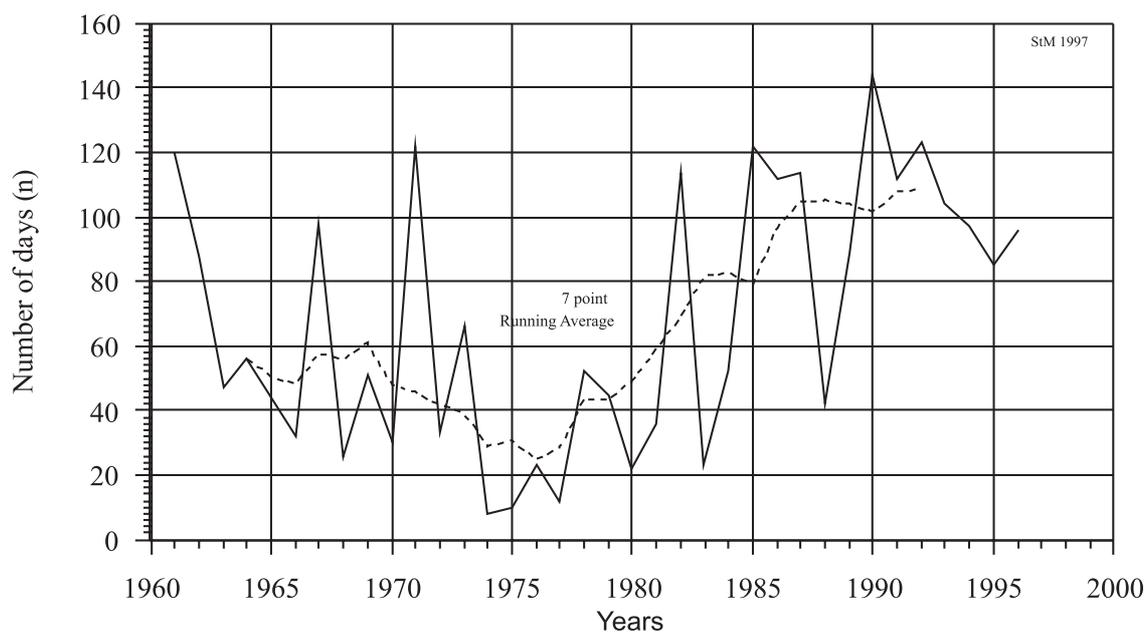
**Fig. 5.** Change of the annual number of days (n) with affected navigation conditions for the Danube river (common Bulgarian - Romanian Section).

It depends from the crossings (bottlenecks) regime and space dimensions of the riverbed. The development of the negative impacts is well seen on fig,5.
